Minerals Inspection Report

Mine Name: Cottonwood Mine	Permit Number: M/47/0064	Mine Status: Inactive
Operator Name: American Gilsonite Corp.	Inspection Date: 10/04/2016	Permit Fees: Paid
Inspector(s): A. Abate	Inspection Time: 1:00 PM	Bond Amount: \$130,000
Attendee(s): Jonathan, company	Weather: Clear 60F	Bond Escalation: 11/17/2006
Inspection Purpose: Annual inspection		Prior Inspection:

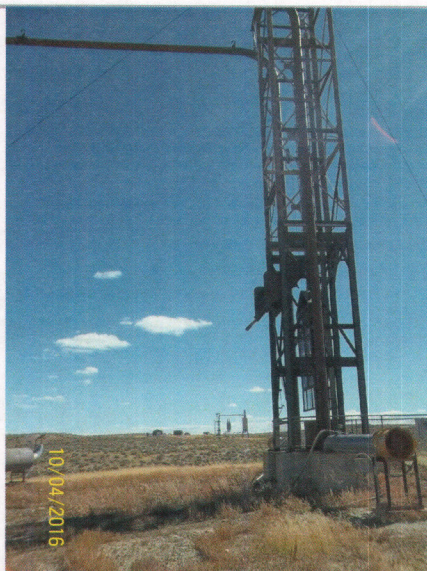
Cottonwood #2 - furthest to the west

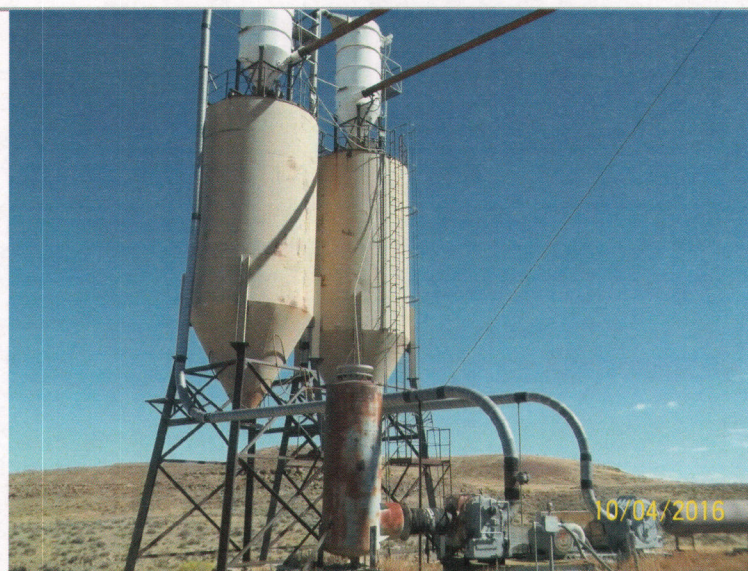
Bins on Cottonwood #2

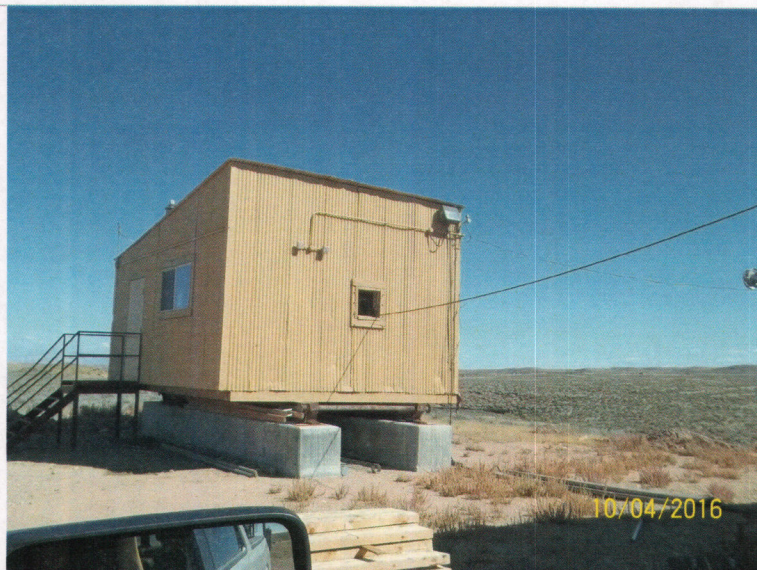
New hoist house added recently

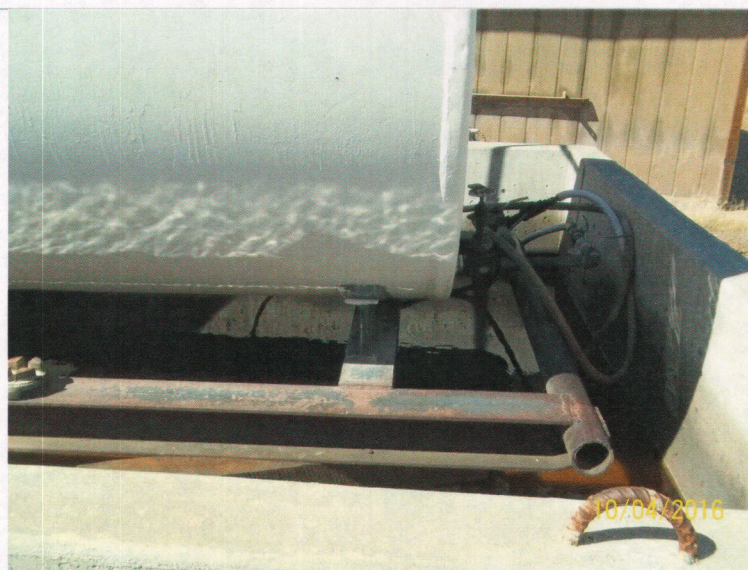
3. <i>Protection of Drainages/Erosion Control</i>	<input type="checkbox"/>	<input type="checkbox"/>
4. <i>Deleterious Material</i>	<input checked="" type="checkbox"/>	<input type="checkbox"/>
Fuel tanks were housed in concrete secondary containment. Minor amounts of rainwater was noted in the structures with some sheen but the structures were holding and there was no evidence of any leakage.

Minor amounts of standing water were in the secondary containment structures.
